NATIONAL TRANSPORTATION SAFETY BOARD

MATERIALS LABORATORY FACTUAL REPORT

Report No. 17-037

Place : Chalmers, Indiana
Date : March 14, 2017
Vehicle : MD Helicopter 369FF, N530KD
NTSB No. : CEN17FA127
Investigator : Joshua Lindberg

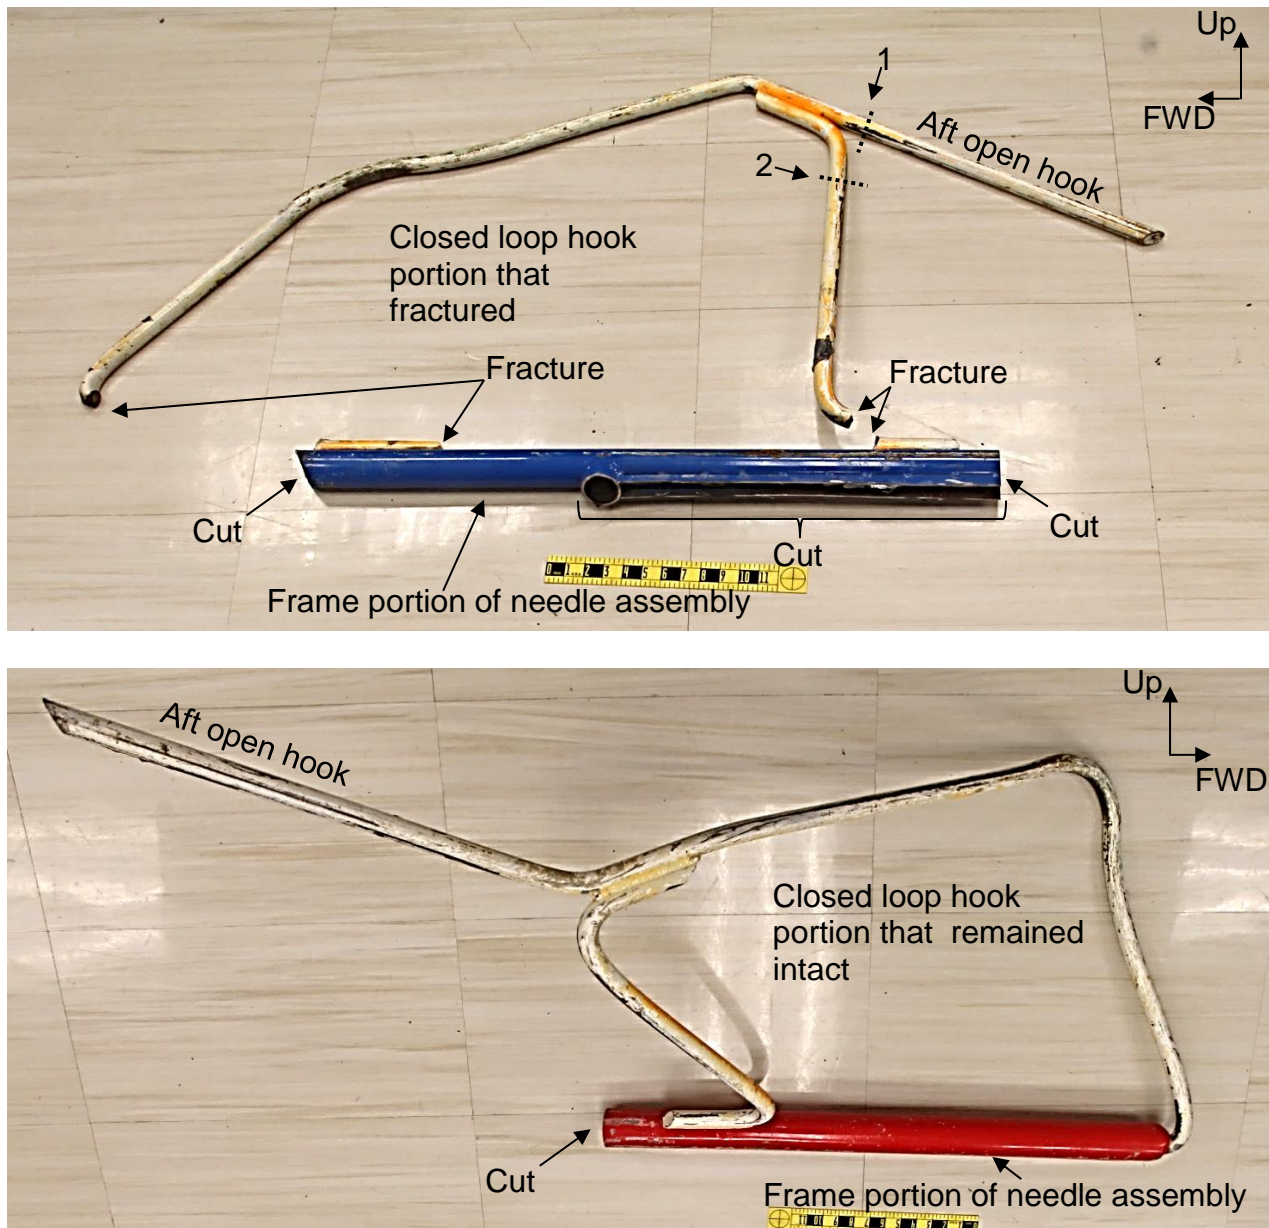
Photographs of the as-received portions of the fractured needle assembly is shown in figures 1 and 2. The needle assembly contained a closed loop hook at the center and leading end. To move the needle assembly from one tower to the other, or to either side of a tower, during an aerial threading operation, a helicopter would have attached a device such as a grappling hook to either one of the closed loop hooks. The top portion of each closed loop hook also contained an open hook portion that faced aft. When passing a needle assembly through a tower structure, the open hook portion would temporarily be attached to the underside of the cross-member portion of the tower. The closed and open loop portions were made from solid round bar stock steel, and they were attached by a weld to each other and the body (frame) of the needle assembly. The frame was made from steel tube.

Visual examination of the needle assembly revealed the closed loop hook fractured at two locations. The fractures were through the round solid bar portion and intersected a portion of the weld at the frame portion. The fracture faces were cleaned with Alconox, a commercial detergent. Bench binocular microscope examination of the fracture faces revealed rough texture features on slant planes consistent with ductile-bending overstress separation, with no evidence of a preexisting crack, such as fatigue crack. The welds at the fracture face showed no evidence of defects such as porosity.

A metallurgical section was made through the loop portions in the areas indicated by arrows "1" and "2" in figure 1, in order to obtain an approximately 0.3 inch thick disc portion from the solid round bar. The diameter of the entire solid round bar stock steel measured approximately 1 inch. Rockwell hardness testing of the flat cut faces (which were perpendicular to the length of the solid round bar) each produced average hardness values

of 93 HRB, which converted to a tensile strength of approximately 94,000 pounds per square inch.¹

The closed loop hook (solid round bar) portion at the leading end of the needle assembly contained no evidence of a crack or fracture.

Figure 1. As-received portions of the fractured needle assembly showing the hooks at the center portion of the needle assembly (upper side of the page) and leading end portion of the needle assembly (lower side of page).

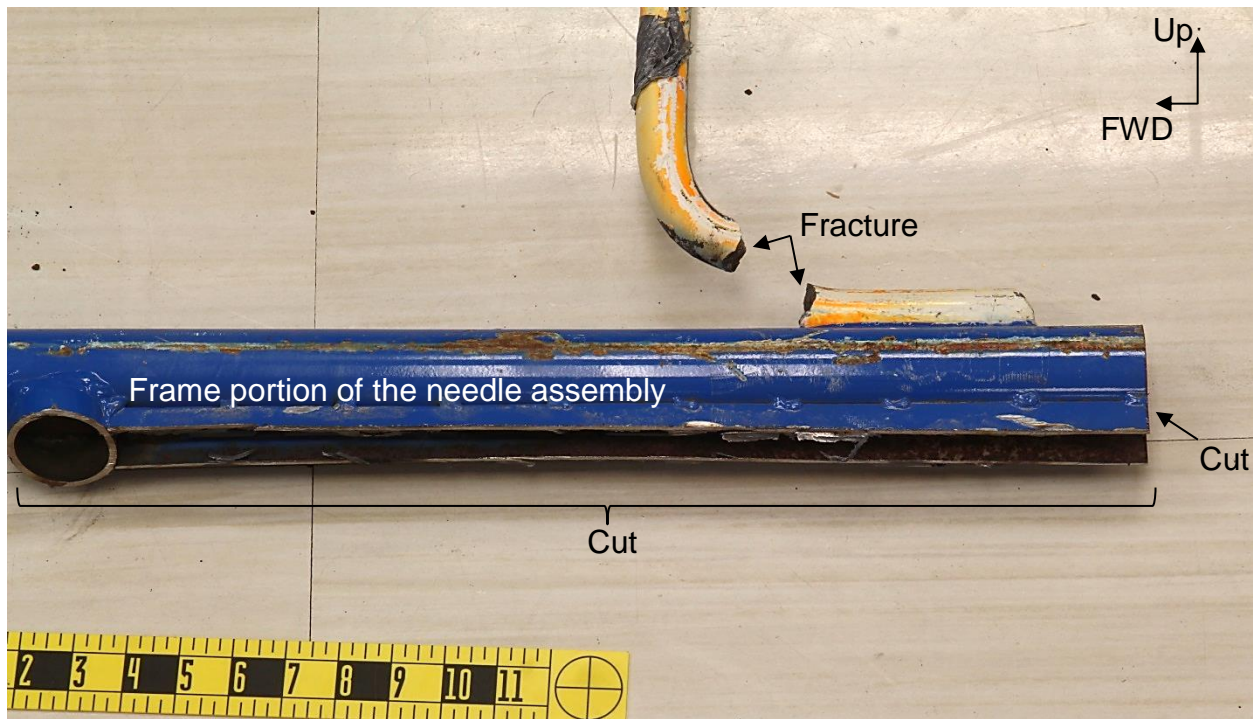
Figure 2. Close-up photograph showing one end of the fractured hook at the center portion of the needle assembly.
